Investigation of Chip Damage in Residential Windows

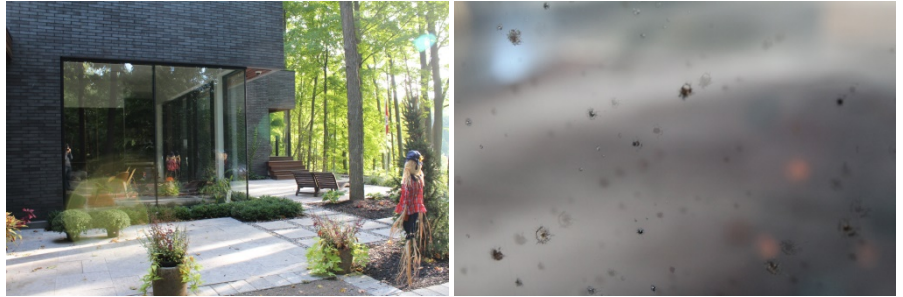
A careful visual examination of the site and windows was conducted. The pattern and distribution of window damage was analyzed to determine the probable source of the damage. The examination revealed that the chips were most heavily concentrated in a relatively small area near the base of one of the windows. Chips were progressively more sparsely distributed, and progressively more elongated, with increasing distance from that area.

The pattern and distribution of damage was highly consistent with a single concentrated source at one location and not consistent with naturally wind-blown debris. Origin and Cause Inc. concluded that the windows had likely been struck and damaged by small rock particles ejected from the saw used to cut the hardscaping materials installed by the landscapers.
